Cutters Crabhouse Restaurant-Infrastructure Upgrades

Case Study

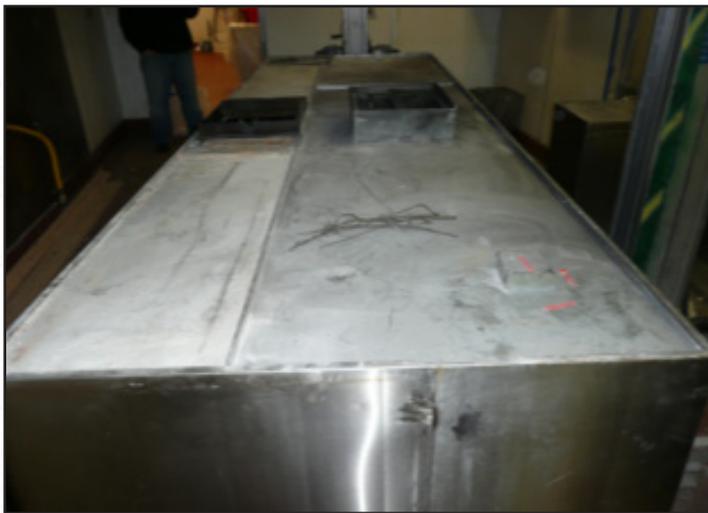
Grease hood removed and retrofitted so it could be reused.

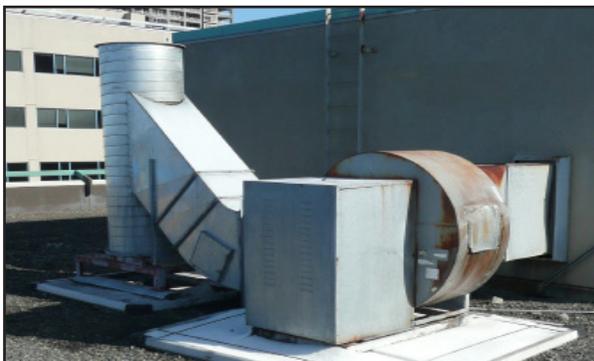
Original exhaust fan and duct work.

The kitchen includes multiple cooklines, each cookline is supported by a type 1 grease hood. The ductwork that connects to the three large hoods is routed vertically through 5 floors to the roof. The ductwork system was failing in several locations.

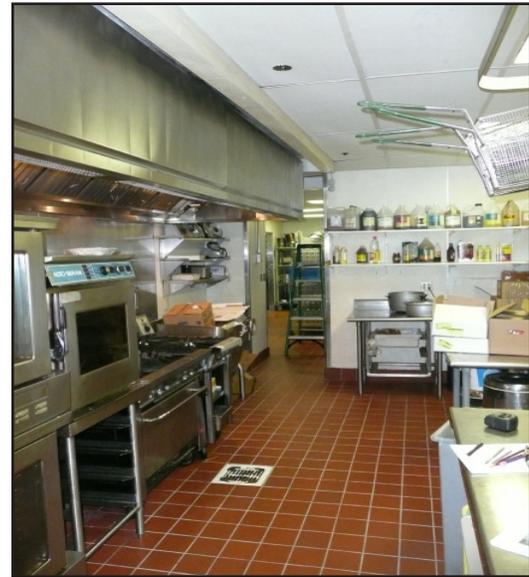
One of the 3 large cooklines supported by the exhaust system upgrade.

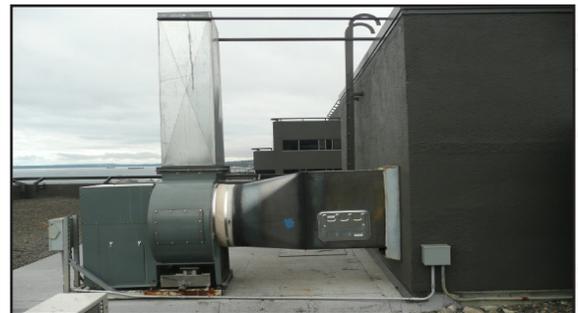
New exhaust fan and duct work.

The final project included the complete replacement of the grease exhaust system through 5 floors and to the roof including a new exhaust fan; a new make up air system for improved ventilation; and a dedicated central plan with multiple boilers and dry coolers to service the restaurants water source heat-pumps.

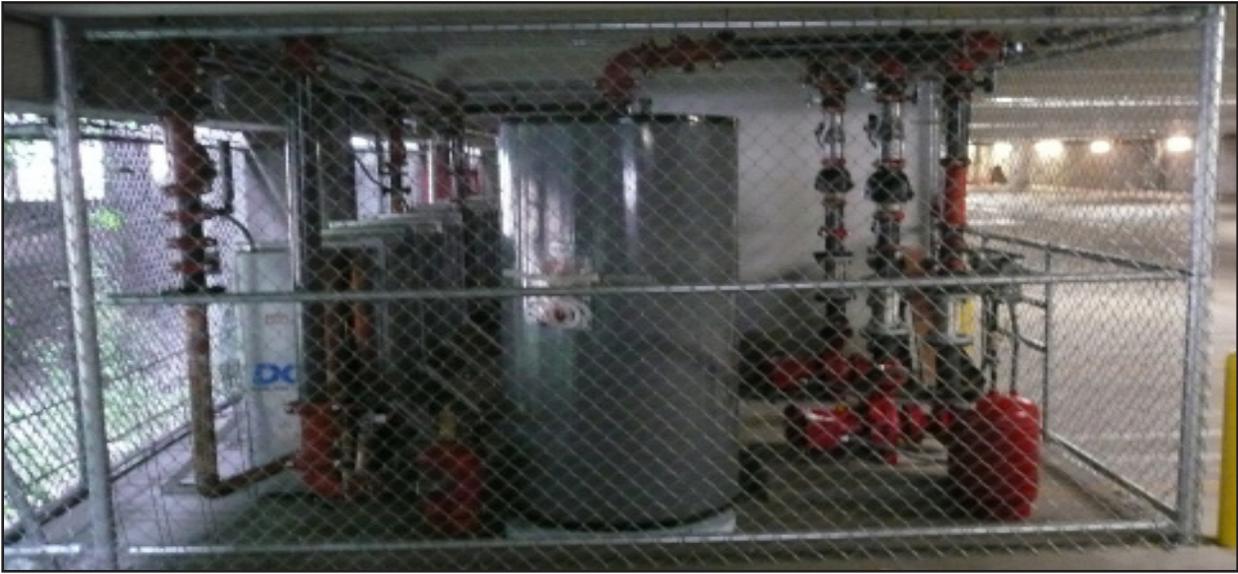
restaurant, which included 11 water source heatpumps, and all associate ductwork. We engineered a small central plant for the restaurant. The central plant was able to be located in parking stalls in the parking garage several floors below the restaurant.

The new central plant. Key components include 97% efficient gas boilers, redundant pumps and dry coolers.
